Panagiotopoulos Building

The "Panagiotopoulos" historical 3-storey building is located at the center of Egio city at the corner of Panagiotopoulou and Mitropoleos str. Based on saved references the building must have been built around 1857-1860 on a design of the architect Panayiotis Kalkos. It is considered as one of the most important architectural landmarks of south western Greece, due to the architectural form and its rich interior painting and architectural decoration. The building's exterior is decorated with whole marbles all around the openings, and with external marble decorations through the ground floor external walls and the corners of the remaining 2 floors. Apart from the openings which are made of whole marble parts, there are cornices made of coating. The rooftop is molded with cornice of whole marbles and is covered by wooden roof trusses with Byzantine type tiles.

The buildings' Repair and Restoration design was completed in 2001 and the works began on February 2005. In 2010 all works were completed and the building was handed over to the owner (Egion Municipality).

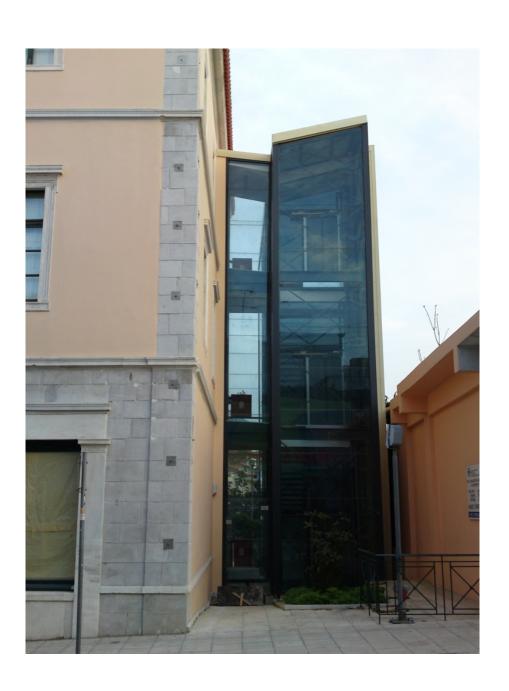
Steel and glass staircase

The restoration of the building structural system included a total (but controlled) replenishment of second floor walls, preserving the elevation towards Mitropoleos street following the strict order of the Ministry of Culture. The walls capacity was increased through injection of concrete mortar in the wall mass, and reinforced concrete coating while stainless rods are used to bind the wall corners. New wooden floors supported on steel beams forming a complete diaphragm are used, in order to cope with the new increased floor loads, as the new use of the building is for music auditorium and concert hall. The interior geometrical dimensions of the building were basically maintained so as not to modify the pictorial décor that was completely restored. Finally, a new exterior steel staircase and elevator for people access were added to this historical building, allowing access by handicapped people.

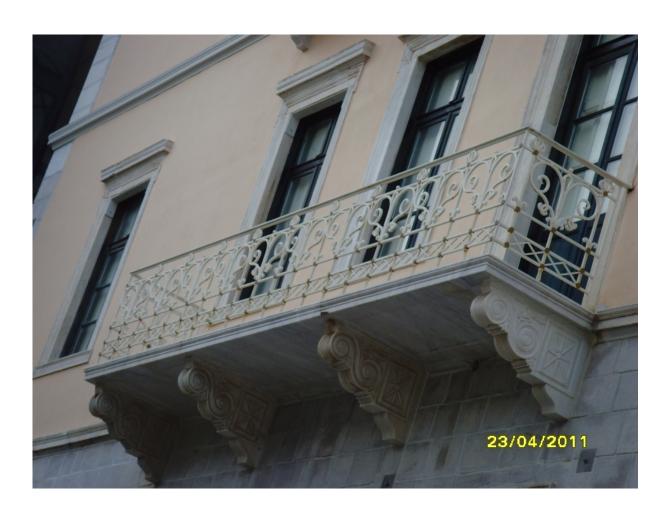
Balcony Detail

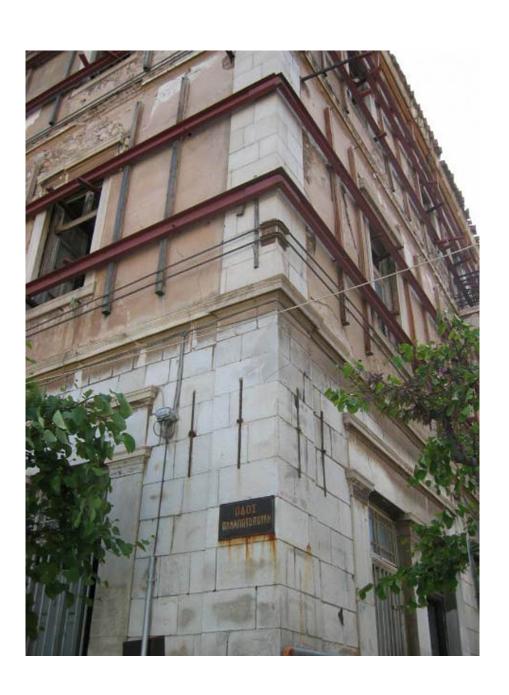
Temporary measures (1998)

Due to the earthquake of June 15th 1995, the building suffered severe damages (partial wall collapse on second floor, full disorganization of stone walls, wall inclination from vertical, etc.), damages increased by the second earthquake of November 18th 1997. As a first temporary stabilization measure, the building was bound by the application of steel sections and wire ropes, following a first quick design performed by our office. Thus collapsing of the building was avoided. Due to the unprotected exposure of the building to weather conditions, additional damages occurred.
